Work Placement Report

“Monitoring of the ecological and morphological changes of the sand nourishment pilot on the Galgeplaat”

Aquatic Ecotechnology Bachelor of Water Management

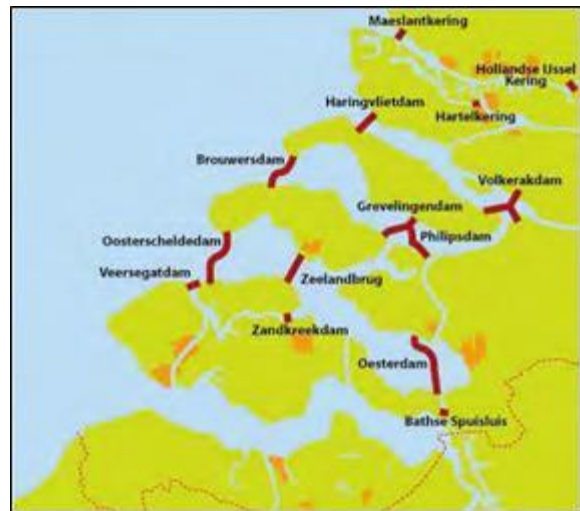
Figure 1: The Delta area since the Delta work

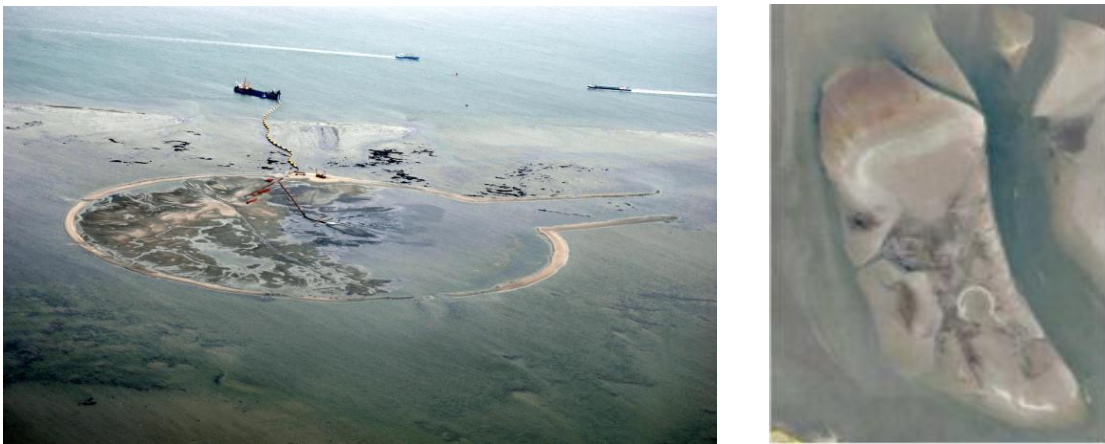
Figure 3: The sand nourishment creation and its location on the Galgeplaat

The following pictures show the creation of the new zone and its location on the Galgeplaat.

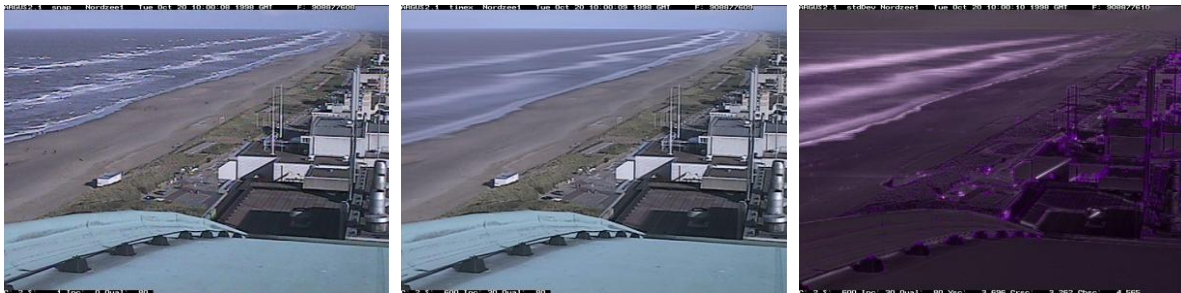
Figure 5: The Argus system three types of images, station Egmond, The Netherlands (left to right: snapshot, time exposure and variance image)

The Argus cameras gather three types of images: a snapshot, a time exposure and a variance image. These images aim at a different functions since they do not indicate the same kind of information. The first kind of pictures, the snapshot images do not provide a lot of information and just serve for documentation for ambient conditions (weather for instance). Time exposure images are a average of ten minutes of the landscape and they are used to map shorelines and analyse changes in beach morphology. Indeed, they average natural modulations in waves breaking and show a smooth line of waves breaking. They also do not reveal temporarily and moving objects such as ship and people. Finally, variance images give information for the regions moving in time (like the sea surface) and this kind of images may help to identify moving regions from the unchanging zones (like dry sand for instance).

The three types of images are presented in Figure 5 (left to right: snapshot image, time exposure image and variance image).

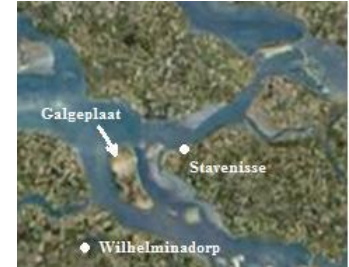
Figure 8: Measurements stations

Meteorological characteristics are used in this report in order to study if they are factors impacting birds occurrence. The water level is used to reference the pictures in Matlab to map morphological aspects of the nourishment. The Figure 8 shows the location of these monitoring stations.

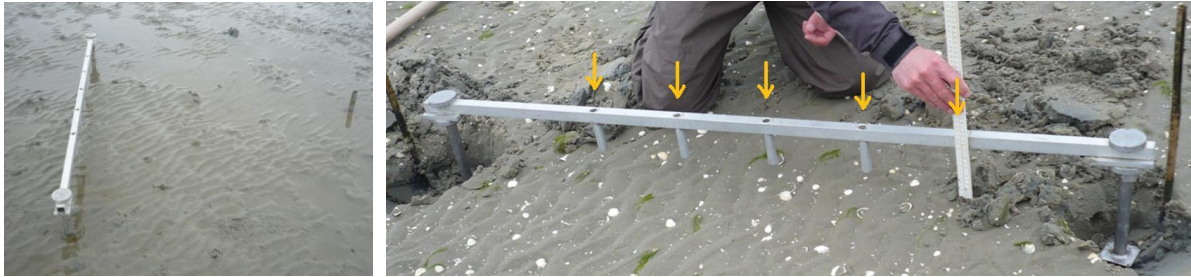
The Figure 9 indicate the way of measurements: on the left photo, the three reference spots that form the triangular zone are viewed, as well as the scale sets for measurements. The orange arrows on the right picture indicate for each of the three lines, the five points where the bed elevation is measured.

Figure 9: Sedimentation-Erosion measurements

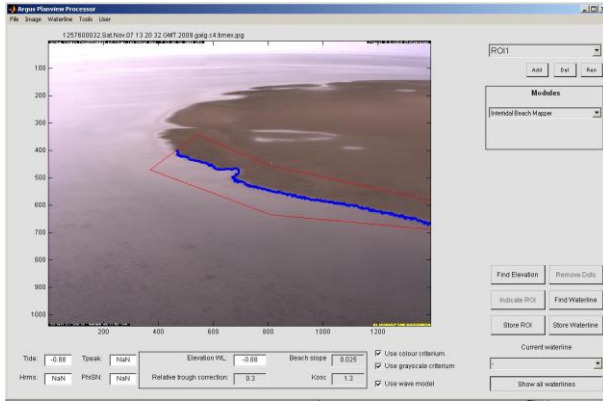
The images underneath show the functioning of the IBM tool of Matlab. The left picture indicates in red the region of interest and in blue the waterline found within the ROI. On the right, the scheme presents the result of the pixel comparison for the same waterline.

Figure 14: IBM tool

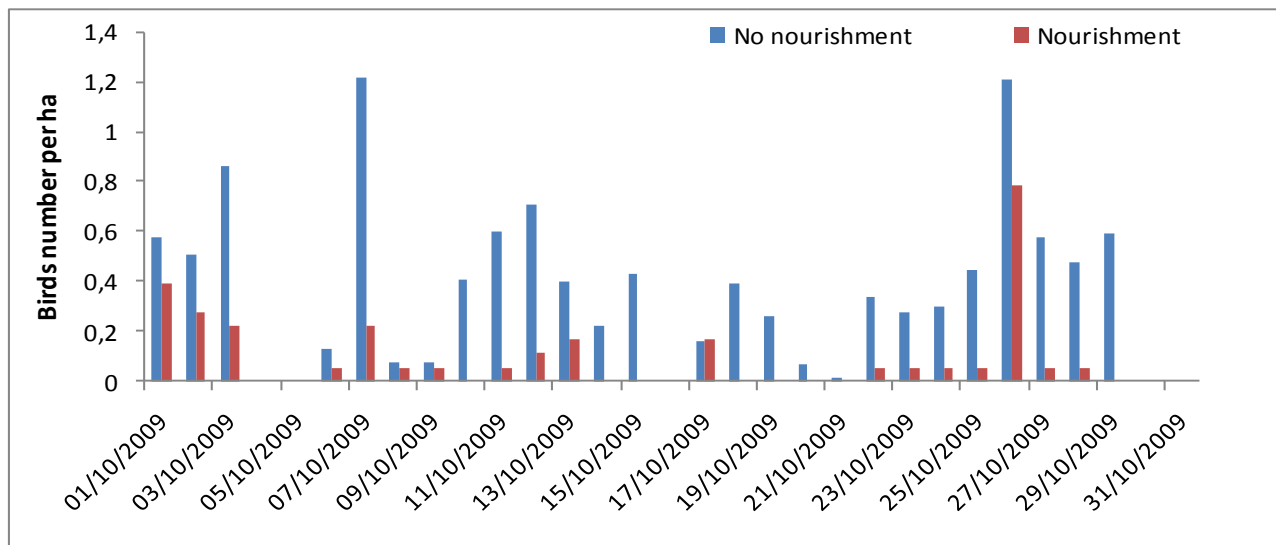
Figure 24: Birds number comparison between nourishment and reference site, Oct 2009

Graphs show a number of birds lower on the nourishment than on the reference site. As an average, less than 20% of the birds have been counted on the nourishment.

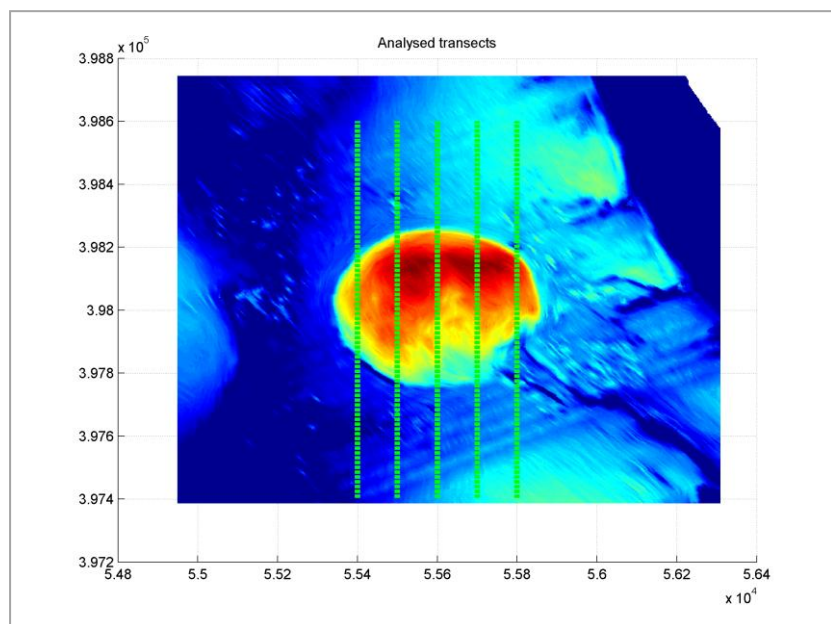
Figure 26: Analysed transects on the nourishment

The transects confirm the impossibility of mapping correctly the North part of the nourishment (on the right side on the graphs in Appendix 6, Appendix 7 and Appendix 8) with the Argus video system since the mapping of waterlines seems to overestimate the size of the nourishment. Furthermore, it appears that the slope on the front part of the nourishment is smoother with the waterlines mapping technique than with field measurements. These discrepancies can be explained by two aspects. The first one is that water level data used in Matlab to reference the bed elevation comes from the measured station located in Stavenisse. The second explanation concerns the geometry solution. Indeed, if the cameras move, the geometry solution changes and it can lead to a distortion of the profile unless the camera is referenced again.

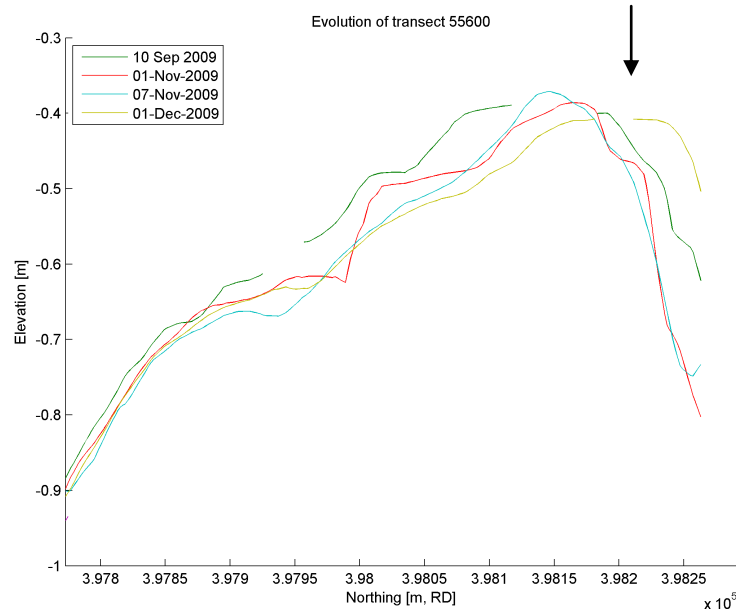
Figure 27: Evolution of the bed elevation of the nourishment, transect 55600

The diagram shows that the nourishment undergoes morphological changes slowly. The slope of the nourishment tends to be smoothed and the entire suppletion seems to move to the North, but this latter change is difficult to gauge since it concerns the part not well-seen with this monitoring technique. These observations have been confirmed by the analysis of by field measurements, but these aspects are not detailed in this report since the analysis is focused on the Argus video results.

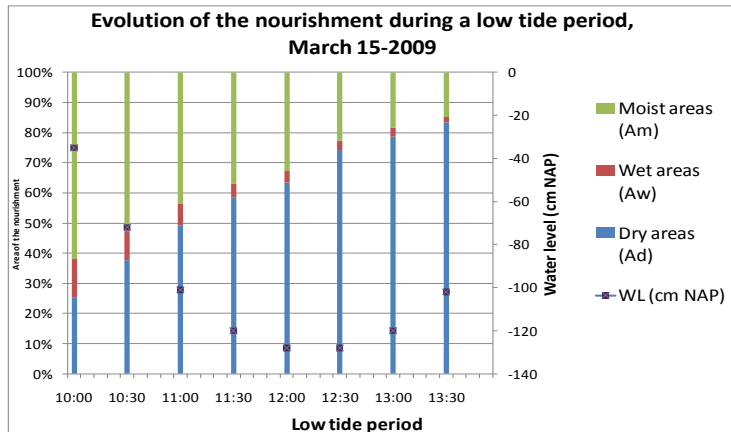
Weather data of sunday 15 March 2009 in Wilhelminadorp	
Temperature : mean (in°C)	7.3
Sun, cloud cover & visibility	
Duration sunshine (hours)	9.5
Relative sunshine duration (%)	81
Relative atmospheric humidity: (%)	84
Precipitation	
24h sum (mm)	0
duration (hour)	0
Wind speed: (m/s)	5,3

The previous graphs indicate that the water seems to be drained away relatively fast since only a small percentage of the nourishment is defined as wet areas. For both dates, less than 30% of the nourishment remains moist or wet at the end of the low period.

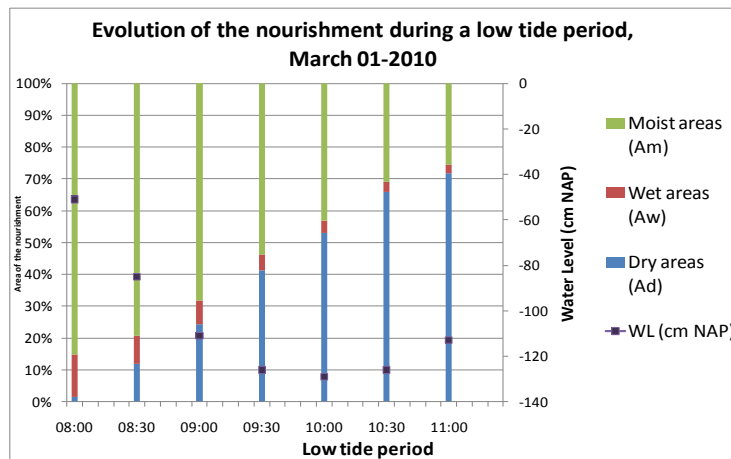
Weather data of sunday 1 March 2010 in Wilhelminadorp	
Temperature : mean (in°C)	3,9
Sun, cloud cover & visibility	
Duration sunshine (hours)	7,7
Relative sunshine duration (%)	71%
Relative atmospheric humidity: (%)	85
Precipitation	
24h sum (mm)	0,9
duration (hour)	2,5
Wind speed: (m/s)	5,2
