## **BUILDING WITH NATURE PILOT SANDY FORESHORE HOUTRIBDIJK DESIGN AND BEHAVIOUR OF A SANDY DIKE DEFENCE IN A LAKE SYSTEM**

Henk Steetzel<sup>1</sup>, Fokko van der Goot<sup>2</sup>, Jasper Fiselier<sup>3</sup>, Marieke de Lange<sup>4</sup>,  
Ellis Penning<sup>5</sup>, Robbin van Santen<sup>6</sup> and Vincent Vuik<sup>7</sup>

### **Abstract**

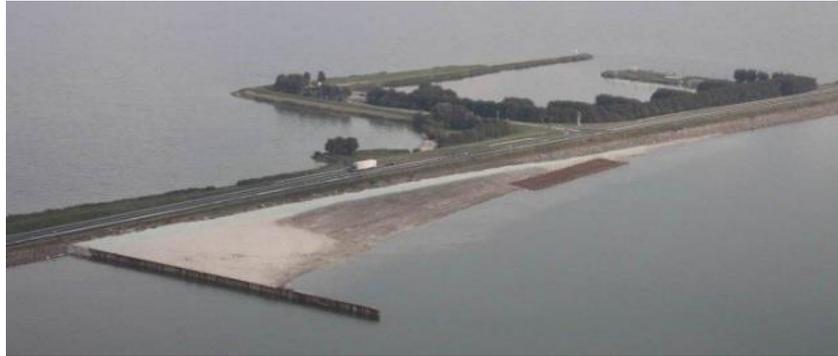
Figure 1 Overview of pilot section direct after construction in September 2014 showing the sheet pile wall and the plot in which clay is mixed in the top layer of the sandy test section (photo: Mennobart van Eerden).

Figure 1 presents an overview of the initial lay-out of the triangular shaped foreshore. The foreshore test section has a length of about 450 m and was constructed in the summer of 2014.

The pilot consists of a sand body of approximately 70,000 m<sup>3</sup>, varying in width and height and is enclosed by a sheet pile wall on the down drift side. The maximum width of the initial beach above the mean water level next to this wall is about 90 m. For the cross-shore profile slopes in the order of 1 in 25 to 30 were designed although the actual construction resulted in somewhat steeper slopes, especially in the lower part of the underwater profile. Locally sourced sediment ( $D_{50}$  ranging from 200 to 600  $\mu\text{m}$  per shipping load yielding an overall average  $D_{50}$  270  $\mu\text{m}$ ) was used for construction. Furthermore, a long wind screen next to the dike was installed to prevent sand to be blown towards the road.

Starting with the overall development, in addition to the 2014 photo (see Figure 1), another aerial photo has been taken in June 2016 (see Figure 3). As can be observed, the vegetation development differs depending on the initial conditions, with the planted sections clearly visible. The one with mainly willow species and clay mixed in the soil shows a denser and greener vegetation. The waterline itself shows some interesting discontinuities due of wave attack from oblique directions just prior to the moment this picture was taken.

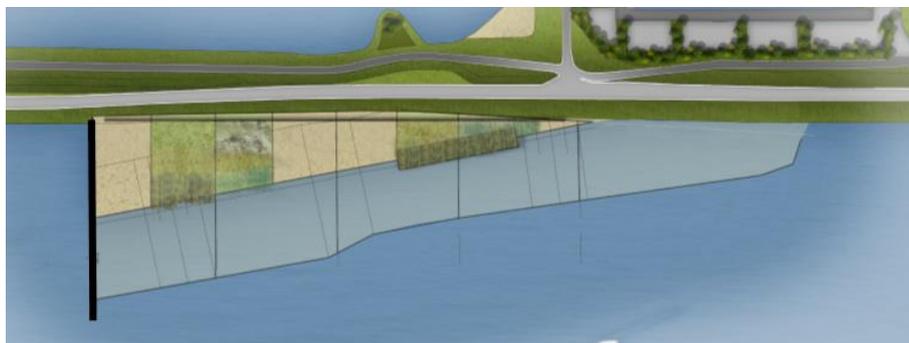
Figure 2 Lay-out of the pilot section with four sections of each 100 m width and each section planted manually, while the other half is left to develop on its own. The willow faggots matras is positioned in the right-hand smaller section.

Figure 2 shows the 100 m wide sections in which either vegetation was been planted manually to kickstart vegetation development or a spontaneous development of vegetation was foreseen (Penning et. al., 2015).

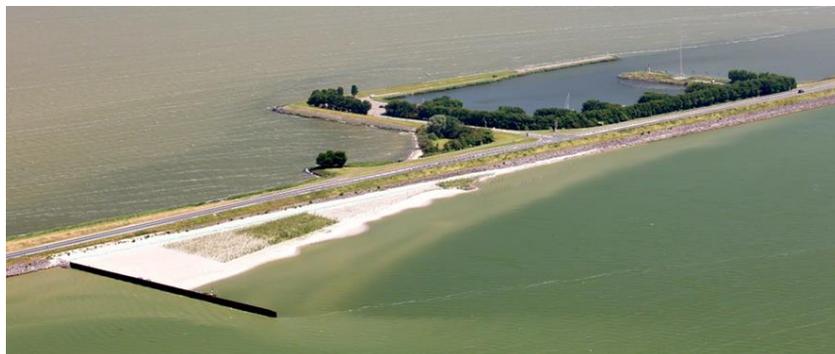
Figure 3 Overview of pilot section direct in June 2016 (two years after construction) showing the adjusted contour as well as the well-developed vegetation in specific plots of the test section (photo: Jurriaan Brobbel).

vegetation was not able to develop at the water line itself. Moreover, vegetation is just not able to stabilize the sand in such a highly dynamic region. Consequently, vegetation remained only present at the higher, dry part of the foreshore.

Furthermore, the willow faggots matras on the outer extent of the test section (upper-right in the figure), installed to protect the initial vegetation proved not to be robust enough and were destroyed during storm events. At this moment (spring 2017), all willow matras have been destroyed completely resulting in one long coastal sandy stretch without solid interruptions along the water line. The remaining willow vegetation in this section was not capable to withstand the hydrodynamic forces, and is also disappearing.

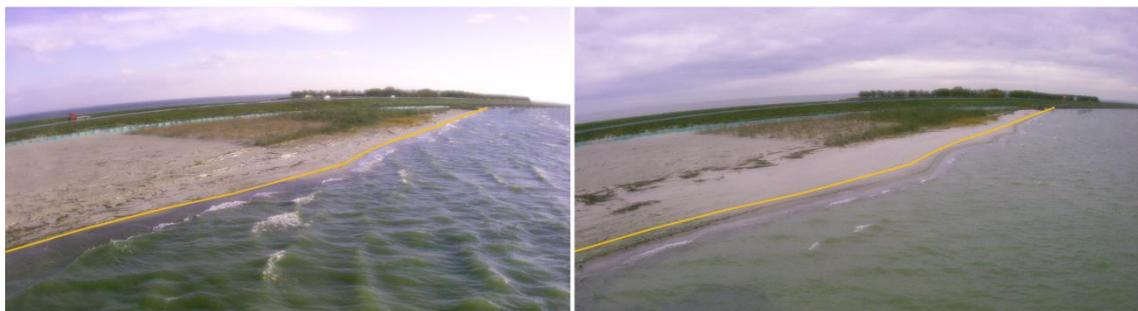
Figure 6a View on the pilot section on November 19 before the storm; Figure 6b View on November 21 after the autumn storm. The yellow line indicates the pre-storm position of the waterline on November 19, 2016.

An indication on the effect of the storm is shown in Figure 6 in which both a photo on the day before as after the storm is shown. From the yellow line, indicating the pre-storm waterline position from Figure 6a, it can be concluded that the impact of the storm, apart from ‘cleaning the higher beach’, was limited. Apparently, the initial pre-storm profile already had a stable shape.
