## NATURAL FORESHORES AS AN ALTERNATIVE TO TRADITIONAL DIKE RE-ENFORCEMENTS: A FIELD PILOT IN THE LARGE SHALLOW LAKE MARKERMEER, THE NETHERLANDS

Natural foreshores are shallow zones and beaches with a gradual slope and a (near-)natural vegetation that can be used as an additional protection against flooding by reducing the wave attack on existing dikes, or can even completely replace an existing dike system. In order to test the applicability of this concept a 500 m long pilot section of a sandy foreshore was constructed along an already existing dike in the large shallow lake Markermeer, the Netherlands. The pilot was equipped with permanent monitoring equipment for hydrodynamics and meteorological conditions and monthly surveys of the morphology of the pilot section. These measurements will be carried out for the coming four years. This paper presents the first results after the construction and the first winter season with the pilot in place.

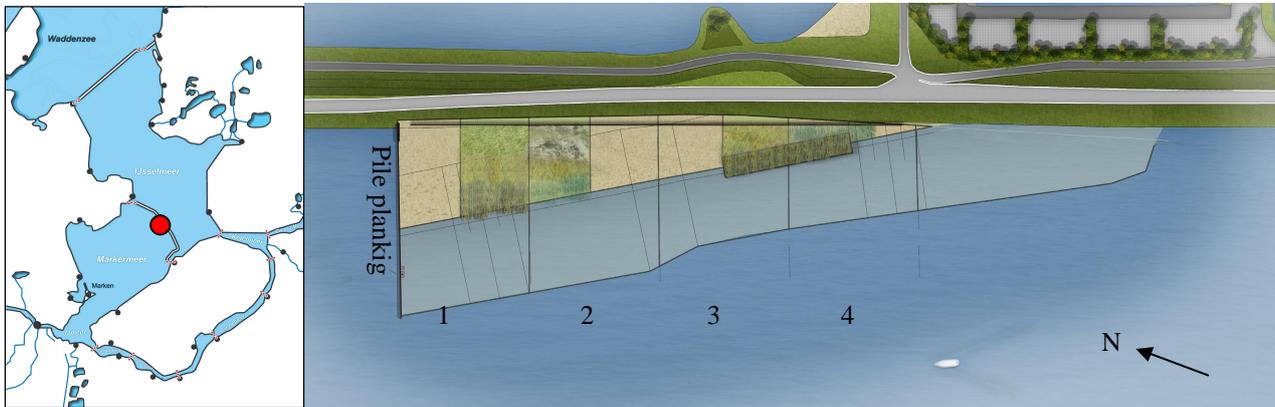
Figure 1 location (red dot) and lay-out of the pilot in Lake Markermeer with the four sections of each 100 m wide, and each section half planted manually, while the other half is left to develop on its own. The willow mats are located in the southern end of the pilot on the waterline.

During the summer of 2014 a pilot section of a sandy foreshore (design slope 1:30 – 1:25) was constructed on the southwestern shore, halfway along the 'Houtribdijk', that separates the two lakes IJsselmeer and Markermeer since 1976. Lake Markermeer (700 km<sup>2</sup>) has a fetch of up to 40 km, and is on average 2-4 m deep, with sections up to 9 m deep in the south-eastern area of the lake. The natural foreshore was created by applying 85.000 m<sup>3</sup> of locally sourced sand using traditional sand nourishment techniques. At the northern end the foreshore is enclosed by pile planking. The pilot was divided into four test sections of each 100 m wide perpendicular to the dike and a fifth 'rest' section completely

below the water line that was not used in the further monitoring of the vegetation development. Two sections received an additional layer of clay carefully mixed through the top 50 cm sand layer to achieve a sand/clay mixture of 70:30 ratio to assess if this would stimulate vegetation development compared to applying sand only. Vegetation will be manually planted on half of each (100 m wide) section in the spring of 2015. On the shores of test section 3 and 4 a willow mat (100 m long, 16 m. wide) with young reed plants was constructed to see if this would allow reeds to establish themselves quicker than in the loose sand (figure 1). Six beacons were installed before construction to measure soil consolidation of the deeper sediment layers below the newly applied sand and grain size distribution was determined for all batches of sand brought to the pilot.

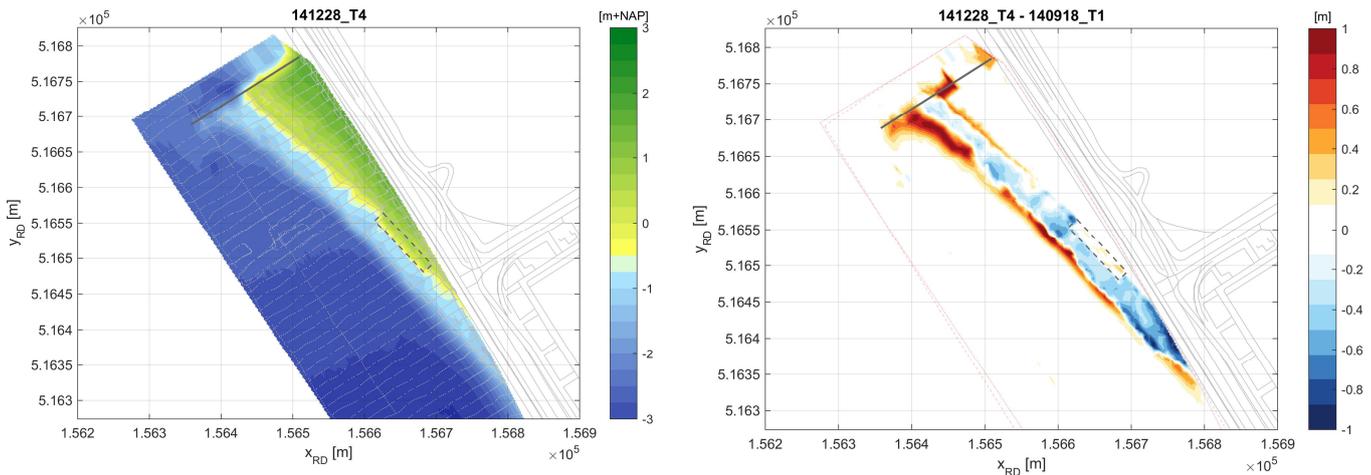
Figure 2a Elevation of the pilot (m +NAP – normalized Amsterdam water level). The average water level of the lake is -0.4 m NAP (light blue). Figure 2b Sedimentation and erosion expressed as changes in relative elevation (m) compared between 15<sup>th</sup> of September (T1) and 28<sup>th</sup> of December (T4).

During the first winter season several storms occurred in the area of the field experiment. Nine storm events with wind speeds over  $15 \text{ m s}^{-1}$  were registered in the period from 15 September 2014 to 1<sup>st</sup> of February 2015. Morphological changes over the full width of the pilot are available for the four times the pilot was visited from September to December 2014 (figure 2a). A strong erosive pattern is seen in the most southern end of the pilot, and sedimentation has occurred in the more protected areas close to the pile planking (figure 2b). The dashed rectangle area delineates the area where the willow mats are placed. Along the pile planking the seemingly strong erosion is due to the interpolation techniques to acquire the full plot pictures. A small sediment bar has been elevated above the average waterline and a plateau shaped underwater profile is starting to develop.

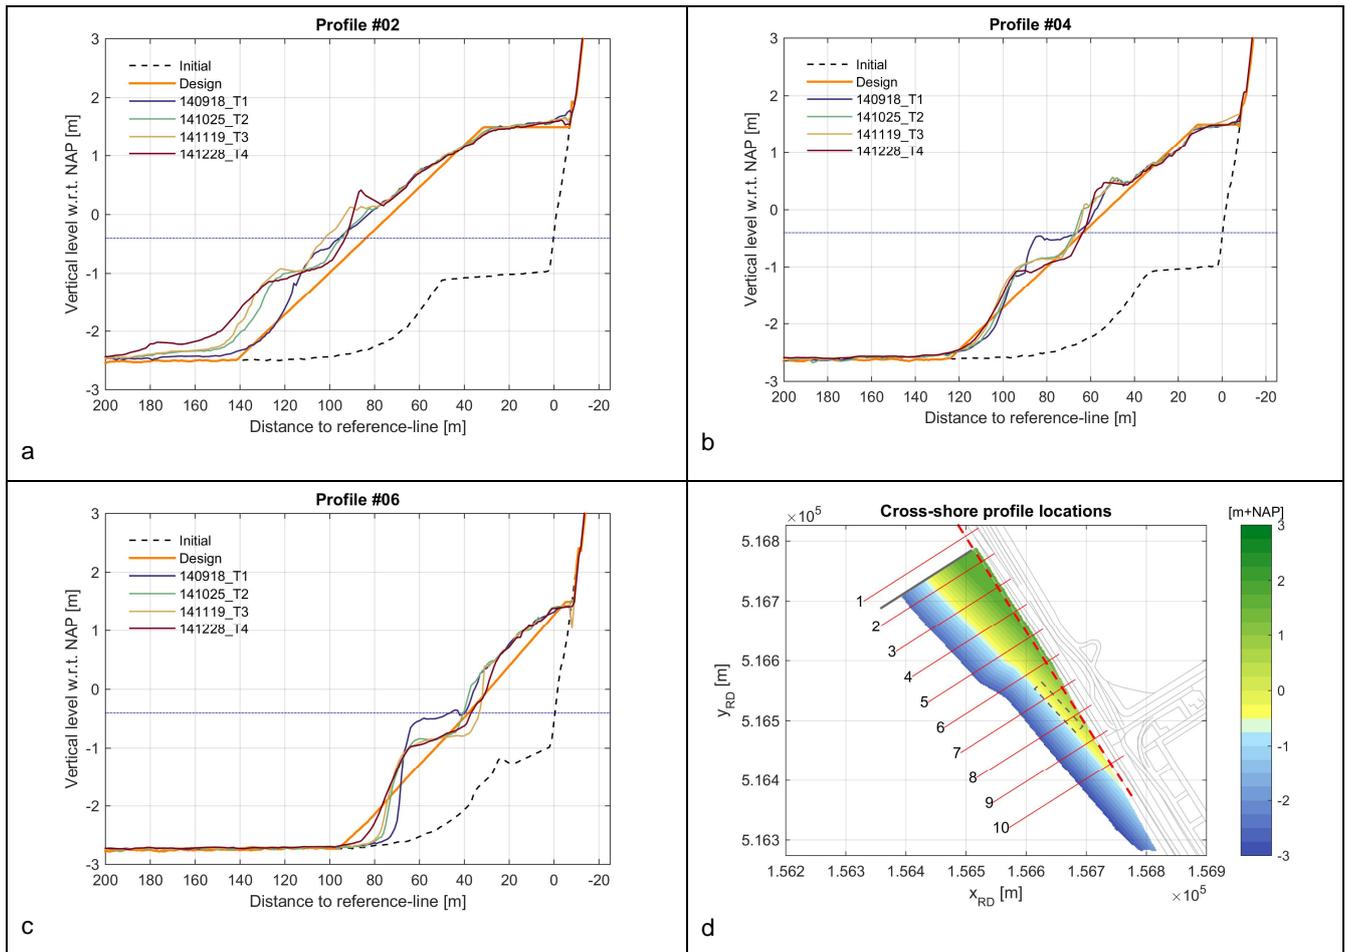
Figure 3a-3c indicate the cross-sectional views of three transects at different locations on the pilot (figure 3d). The average water level is indicated with the light blue line, showing that above the waterline a small sand ridge has formed between T2 (26 October 2014) and T4 (28 of December 2014) in profile 2 and 4, while in profile 6 general erosion of the shallow areas is visible and an increase in the deeper areas. The pilot is designed with two different slopes: 1:30 for the area represented by profiles 2-5 and a slope of 1:25 for profile 6-10. This difference in design is also visible in the field measurements where profile 6 has a steeper slope than profile 2 and 4.

Figure 3a-3c Changes in cross sectional profile at location #2 (a), #4 (b) and #6 (c) over time compared to the original designed profile. The black dashed line represents the original lake bottom (before implementation of the pilot). Location of the different profiles is indicated in figure 3d.
